SANTA SUSANA FIELD LABORATORY

PUBLIC MEETING SITE-WIDE SUMMARY OF ACTIVITIES

SSFL Surface Water Expert Panel

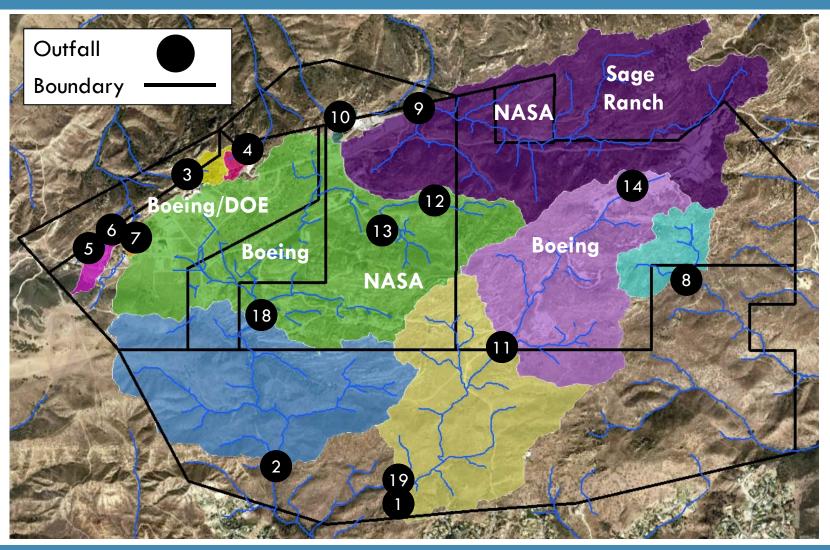
SSFL NPDES Outfalls

- Stormwater discharges at SSFL are regulated by the LARWQCB through an individual NPDES permit, which requires:
 - Composite sampling at outfalls during storms, and
 - Compliance with Numeric Effluent Limits (NELs) protective of both human health and aquatic life
- NELs for a wide range of constituents, including:
 - Dioxins (TCDD TEQ): 0.00000028 µg/L (ppb)
 - Total Copper: 14 µg/L (ppb)
 - Total Lead: 5.2 µg/L (ppb)

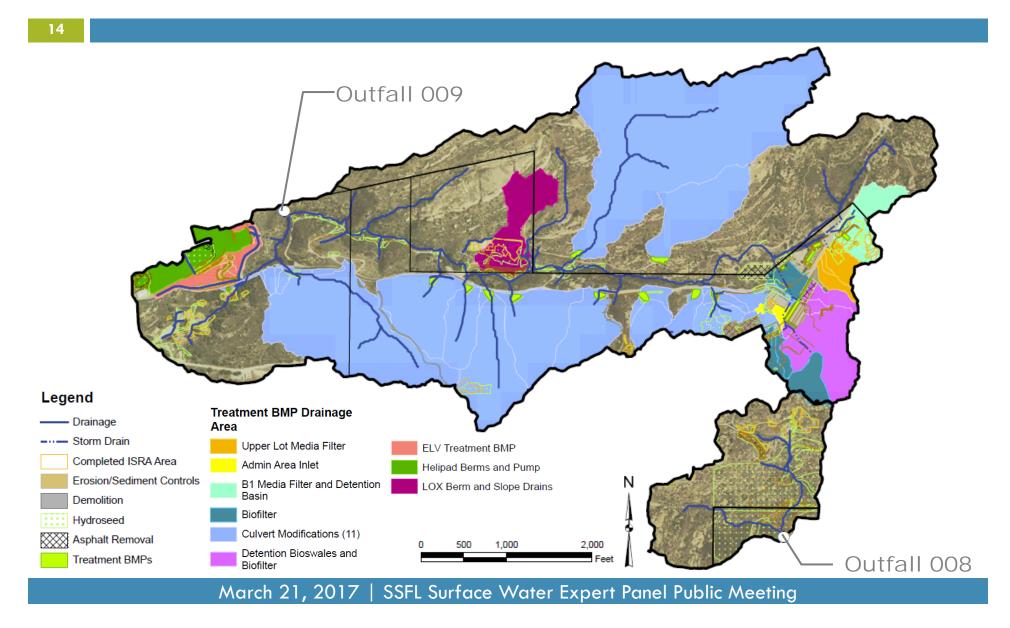
008/009 Treated Areas

- **008:** source removal, erosion control, and restoration
- **009:** the same, plus distributed treatment controls

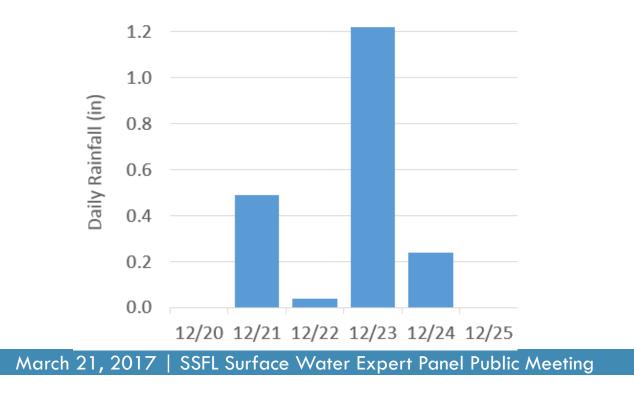
December 22-27, 2016

- Total rainfall = 1.99-in
- Outfall 009 only flowed
 - Sampled December 24th and 25th (grab and composite)
 - No exceedances

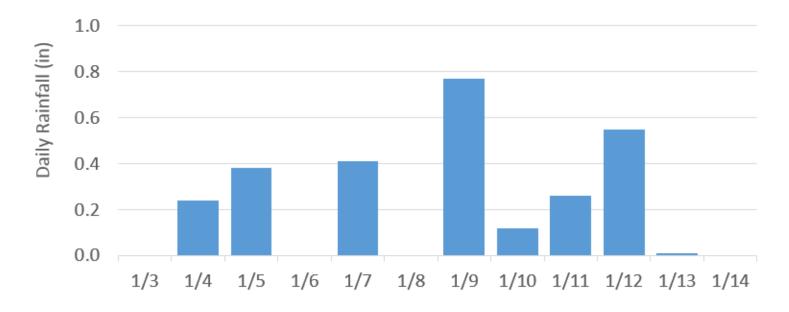
January 4-13, 2017

- □ Total rainfall = 2.74-in
- Outfall 009 only flowed
 - Sampled January 9th and 10th (grab and composite)

No exceedances

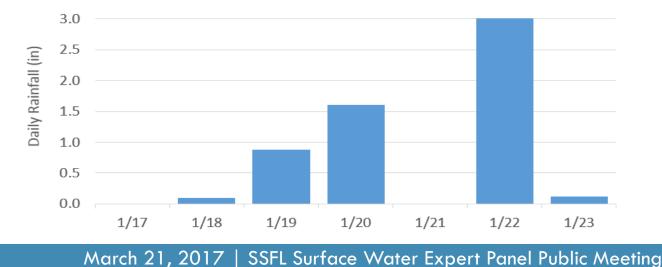
January 18-23, 2017

- Total rainfall = 5.70-in
- Outfalls 001, 002, 006, 008, 009, 011, and 018 flowed
- Only Outfall 008 and 009 results available/validated
- Outfall 009
 - Sampled January 19-21 (grab and composite)
 - No exceedances

- Sampled January 20-21 (grab and composite)
- One exceedance: Field pH = 6.2

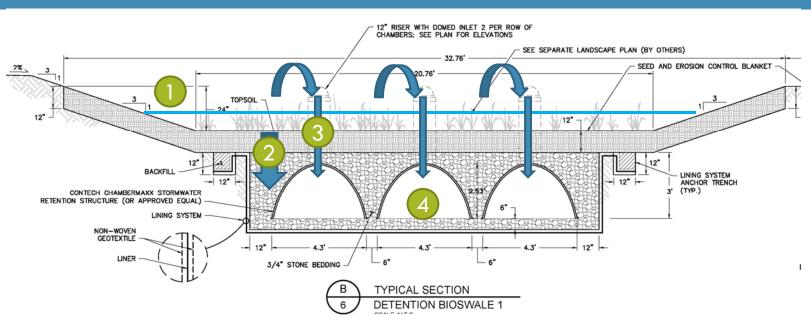
Detention Bioswales

Concept: Hold runoff from upper lot until lower lot runoff is treated, then slowly release for downstream treatment by biofilter.

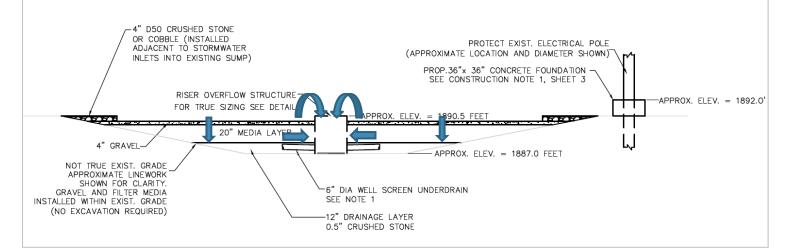
Upper Parking Lot Media Filter

TRITON- TR FILTER SERIE By REM Inc. (888.526.4736) REMEILTERS COM Drop Inlet Filters filled with FLOW Site Media TRITON DROP INLET FILTER (Sand, GAC, Zeolite) CATCH CAPTURED Weighted Wattle filled with FILTERED proprietary media (Perlite, GAC, Zeolite) Sandbag berm to increase settling of solids

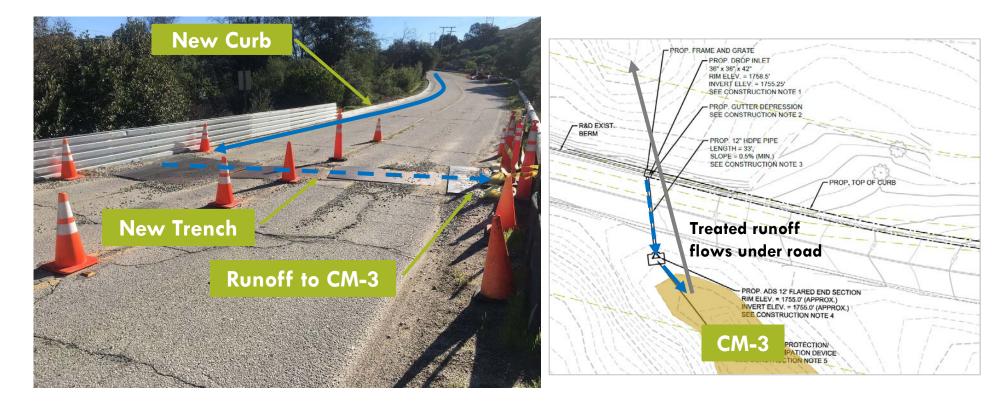
New Road Runoff Inlet to CM-3

Currently under construction; completion pending extended period of dry weather

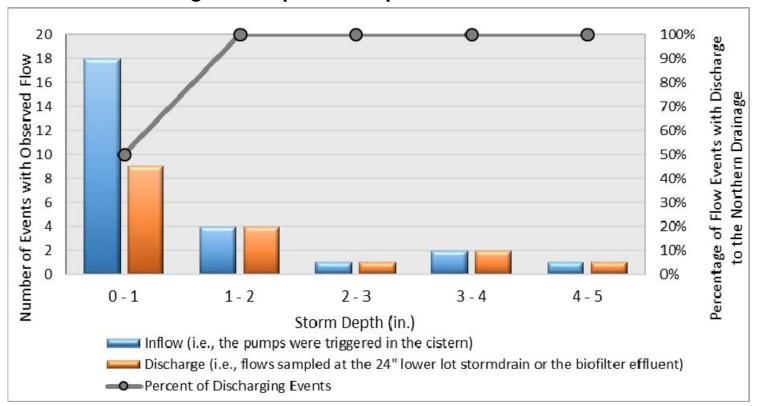
Lower Lot Biofilter Diversion

The diversion to the biofilter prevented half of all small, frequent storms from discharging to the Northern Drainage through evapotranspiration in the BMP

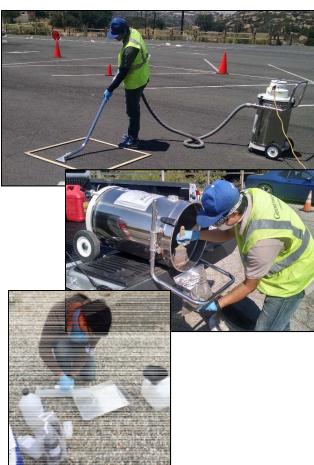
Special Study Preliminary Results

Initial results indicate potential contributors to OF009 stormwater exceedances:

- Dioxins:
 - Soils near treated wood
 - Fine solids from all pavement types (e.g., weathered, newly resurfaced, high/low traffic)
- 🗆 Lead:
 - Atmospheric deposition
 - Fine solids from higher traffic roads

A: Potential contributors include impacted soils and "urban background" sources, such as treated wood and pavement. We continue to address both through BMPs.
