Outfall 008 BMP and ISRA Monitoring

SANTA S U S A N A FIELD

LABORATORY

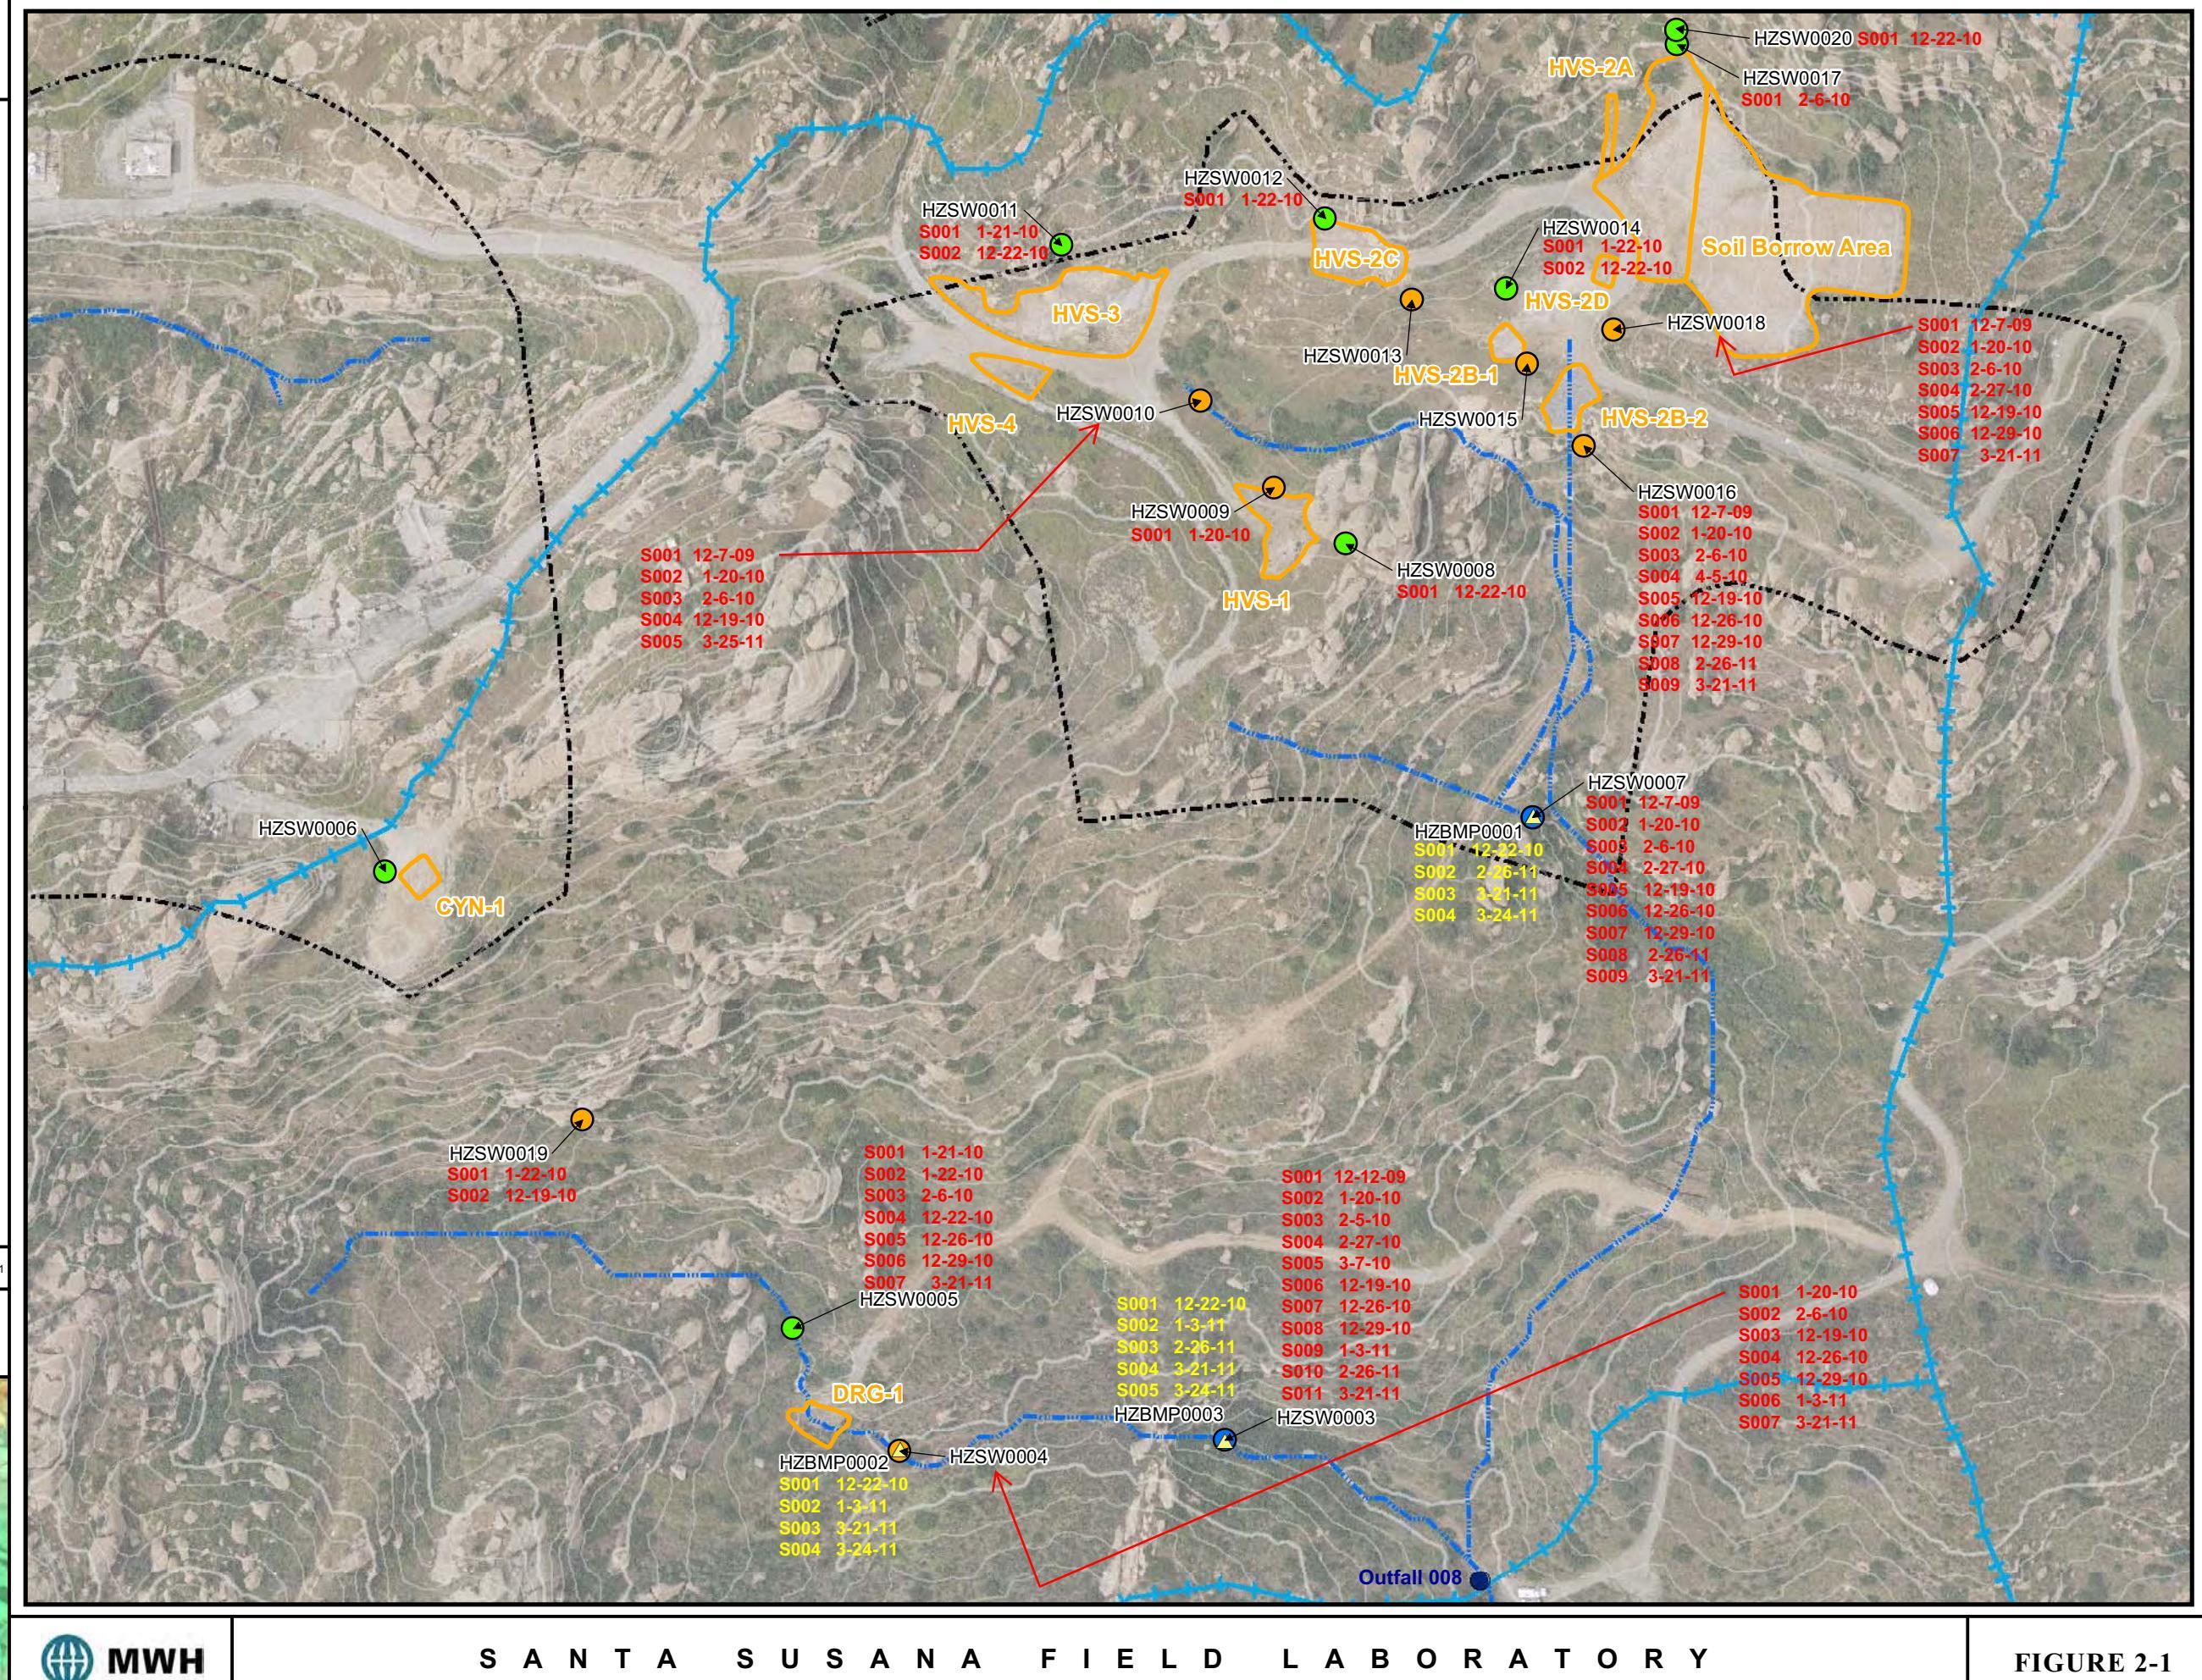
Performance monitoring and potential BMP subarea monitoring inspections were performed at the locations shown on this figure during daylight hours as soon as possible after the rain event began, and at 24 hour intervals during extended rain events. During inspections, if sufficient storm water runoff was observed at a sample location, a sample was collected from the flowing water. The dates on which samples were collected at a location are shown on the Figure; locations with no dates have never been sampled because flowing storm water has never been present during inspections.

Sample location HZSW0020 replaced sample location HZSW0017, per explanation on Table 1-3

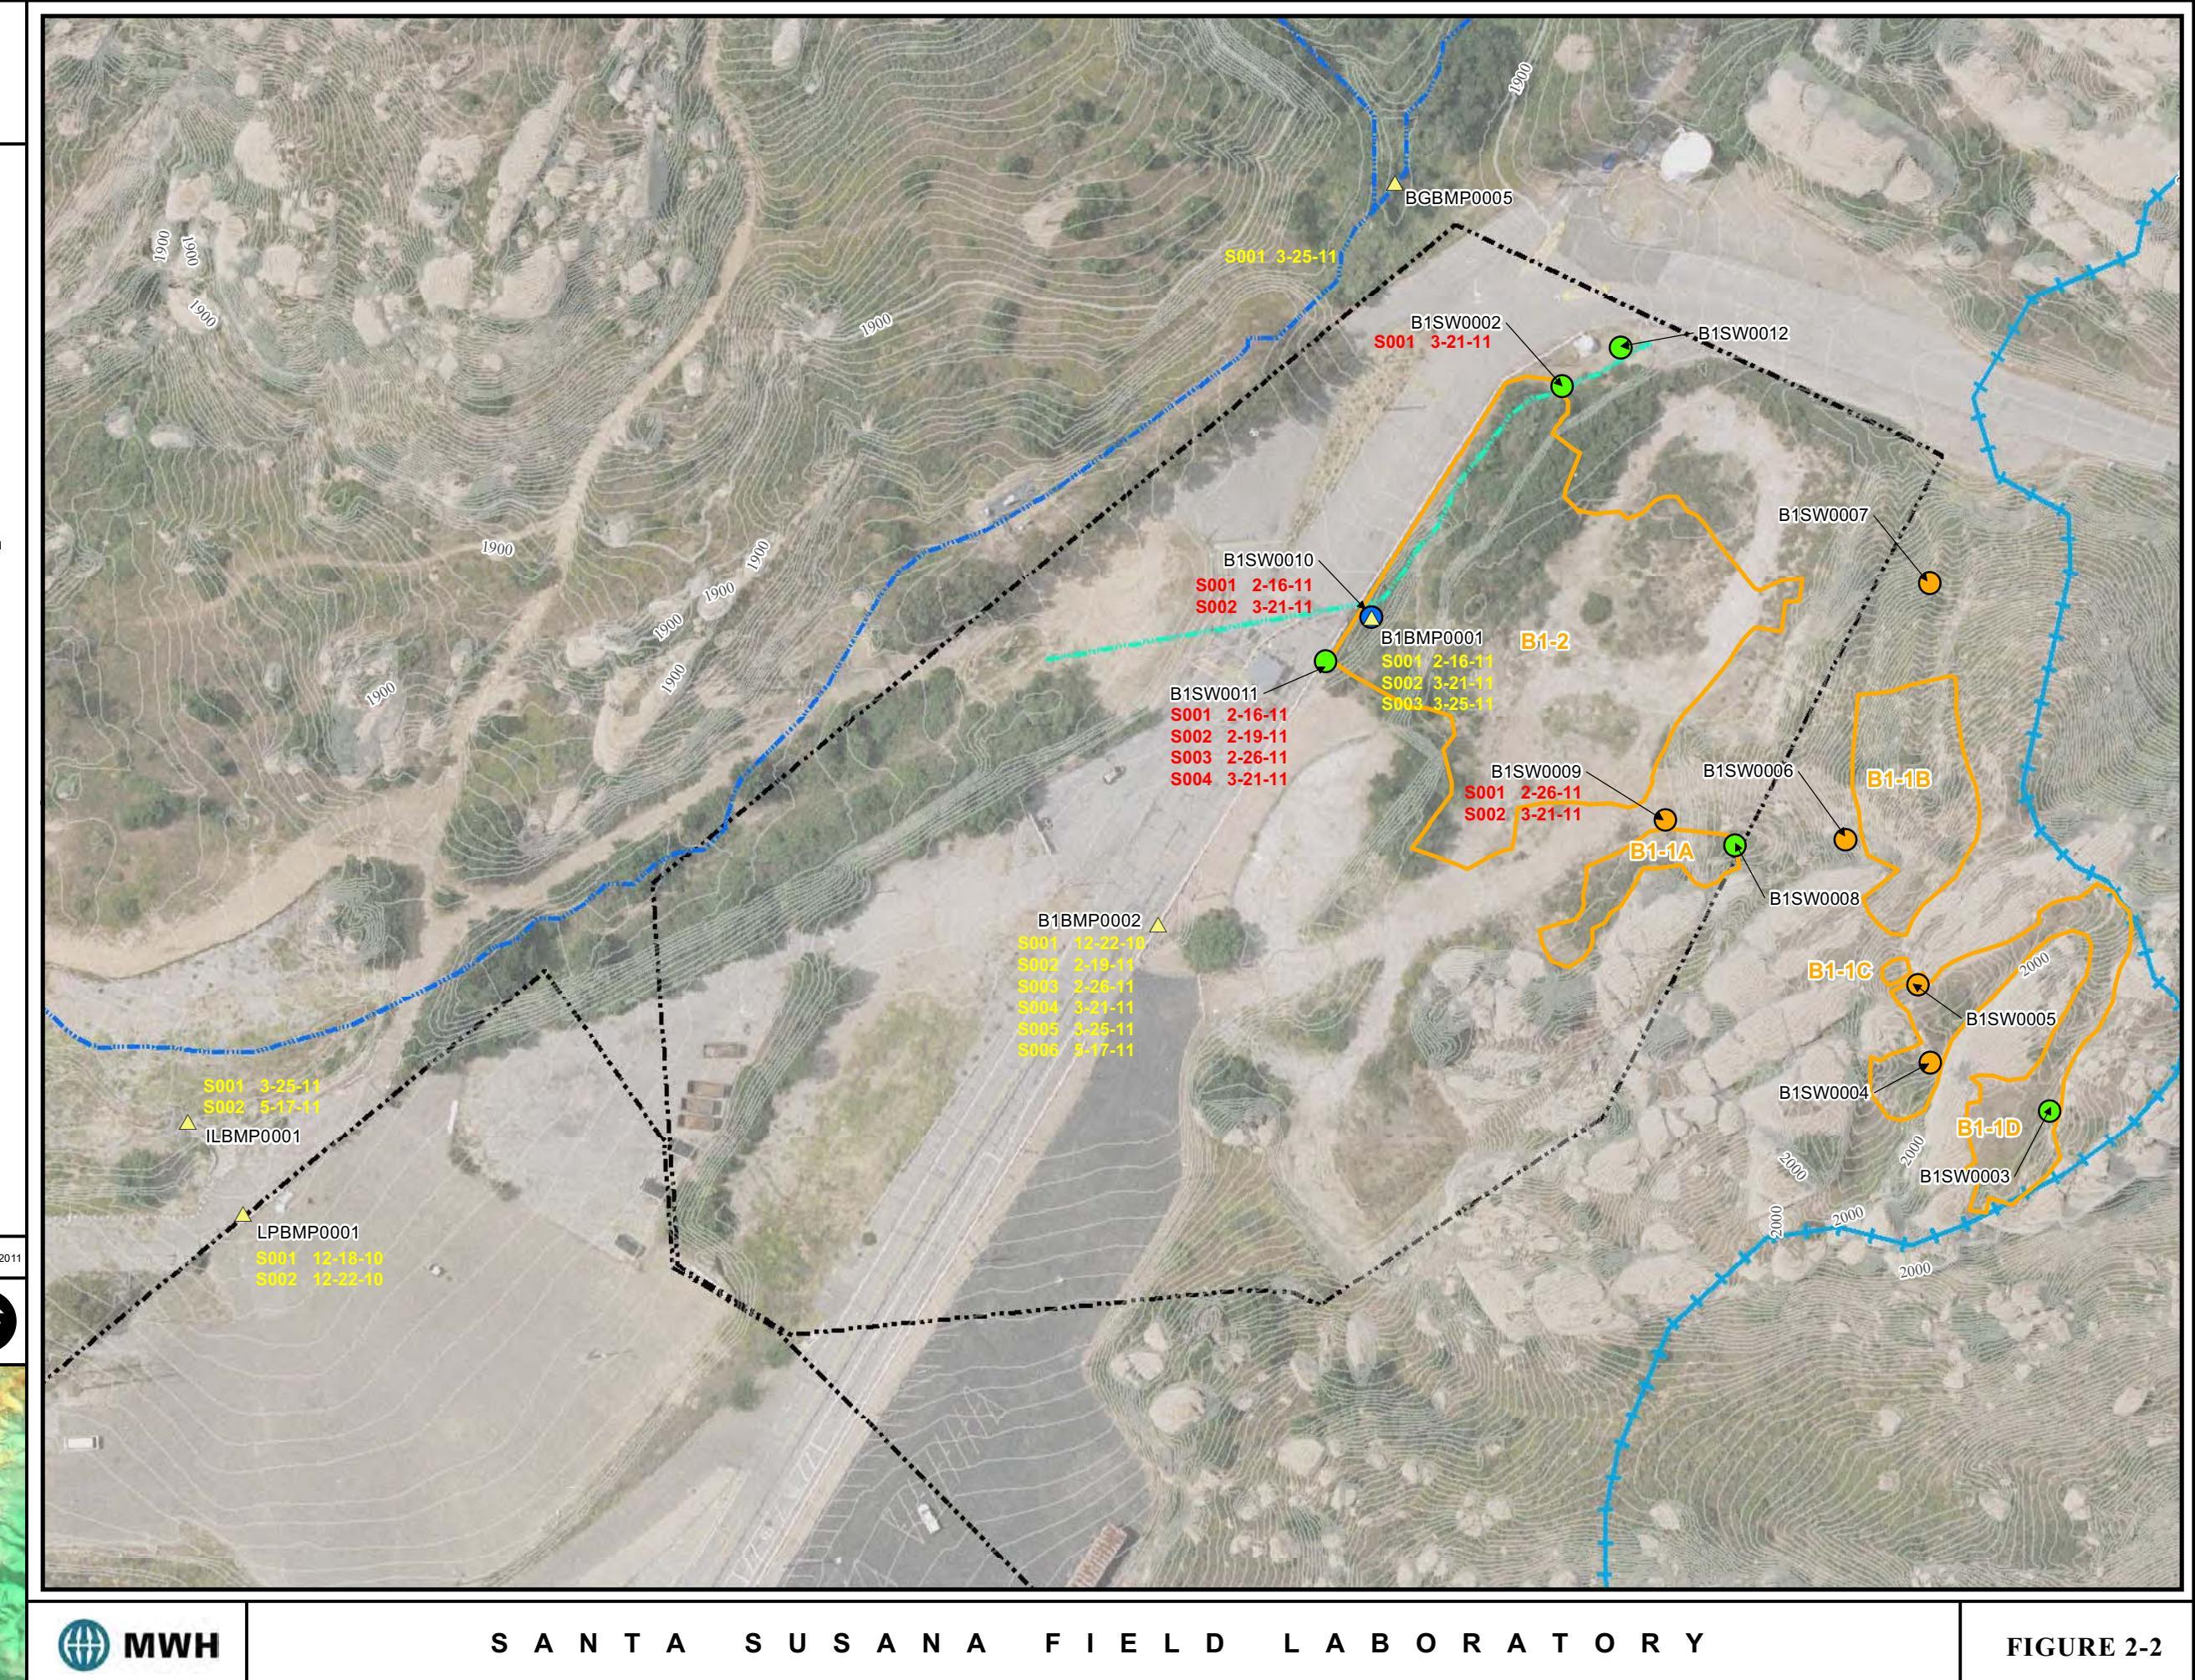
Outfall 009 BMP and ISRA Monitoring B-1 Area

Performance monitoring and potential BMP subarea monitoring inspections were performed at the locations shown on this figure during daylight hours as soon as possible after the rain event began, and at 24 hour intervals during extended rain events. During inspections, if sufficient storm water runoff was observed at a sample location, a sample was collected from the flowing water. The dates on which samples were collected at a location are shown on the Figure; locations with no dates have never been sampled because flowing storm water has never been present during inspections.

- Topographic contours from 2010 Sage Consulting.
 Inspection/sampling at offsite monitoring locations subject
- to property owner approval.

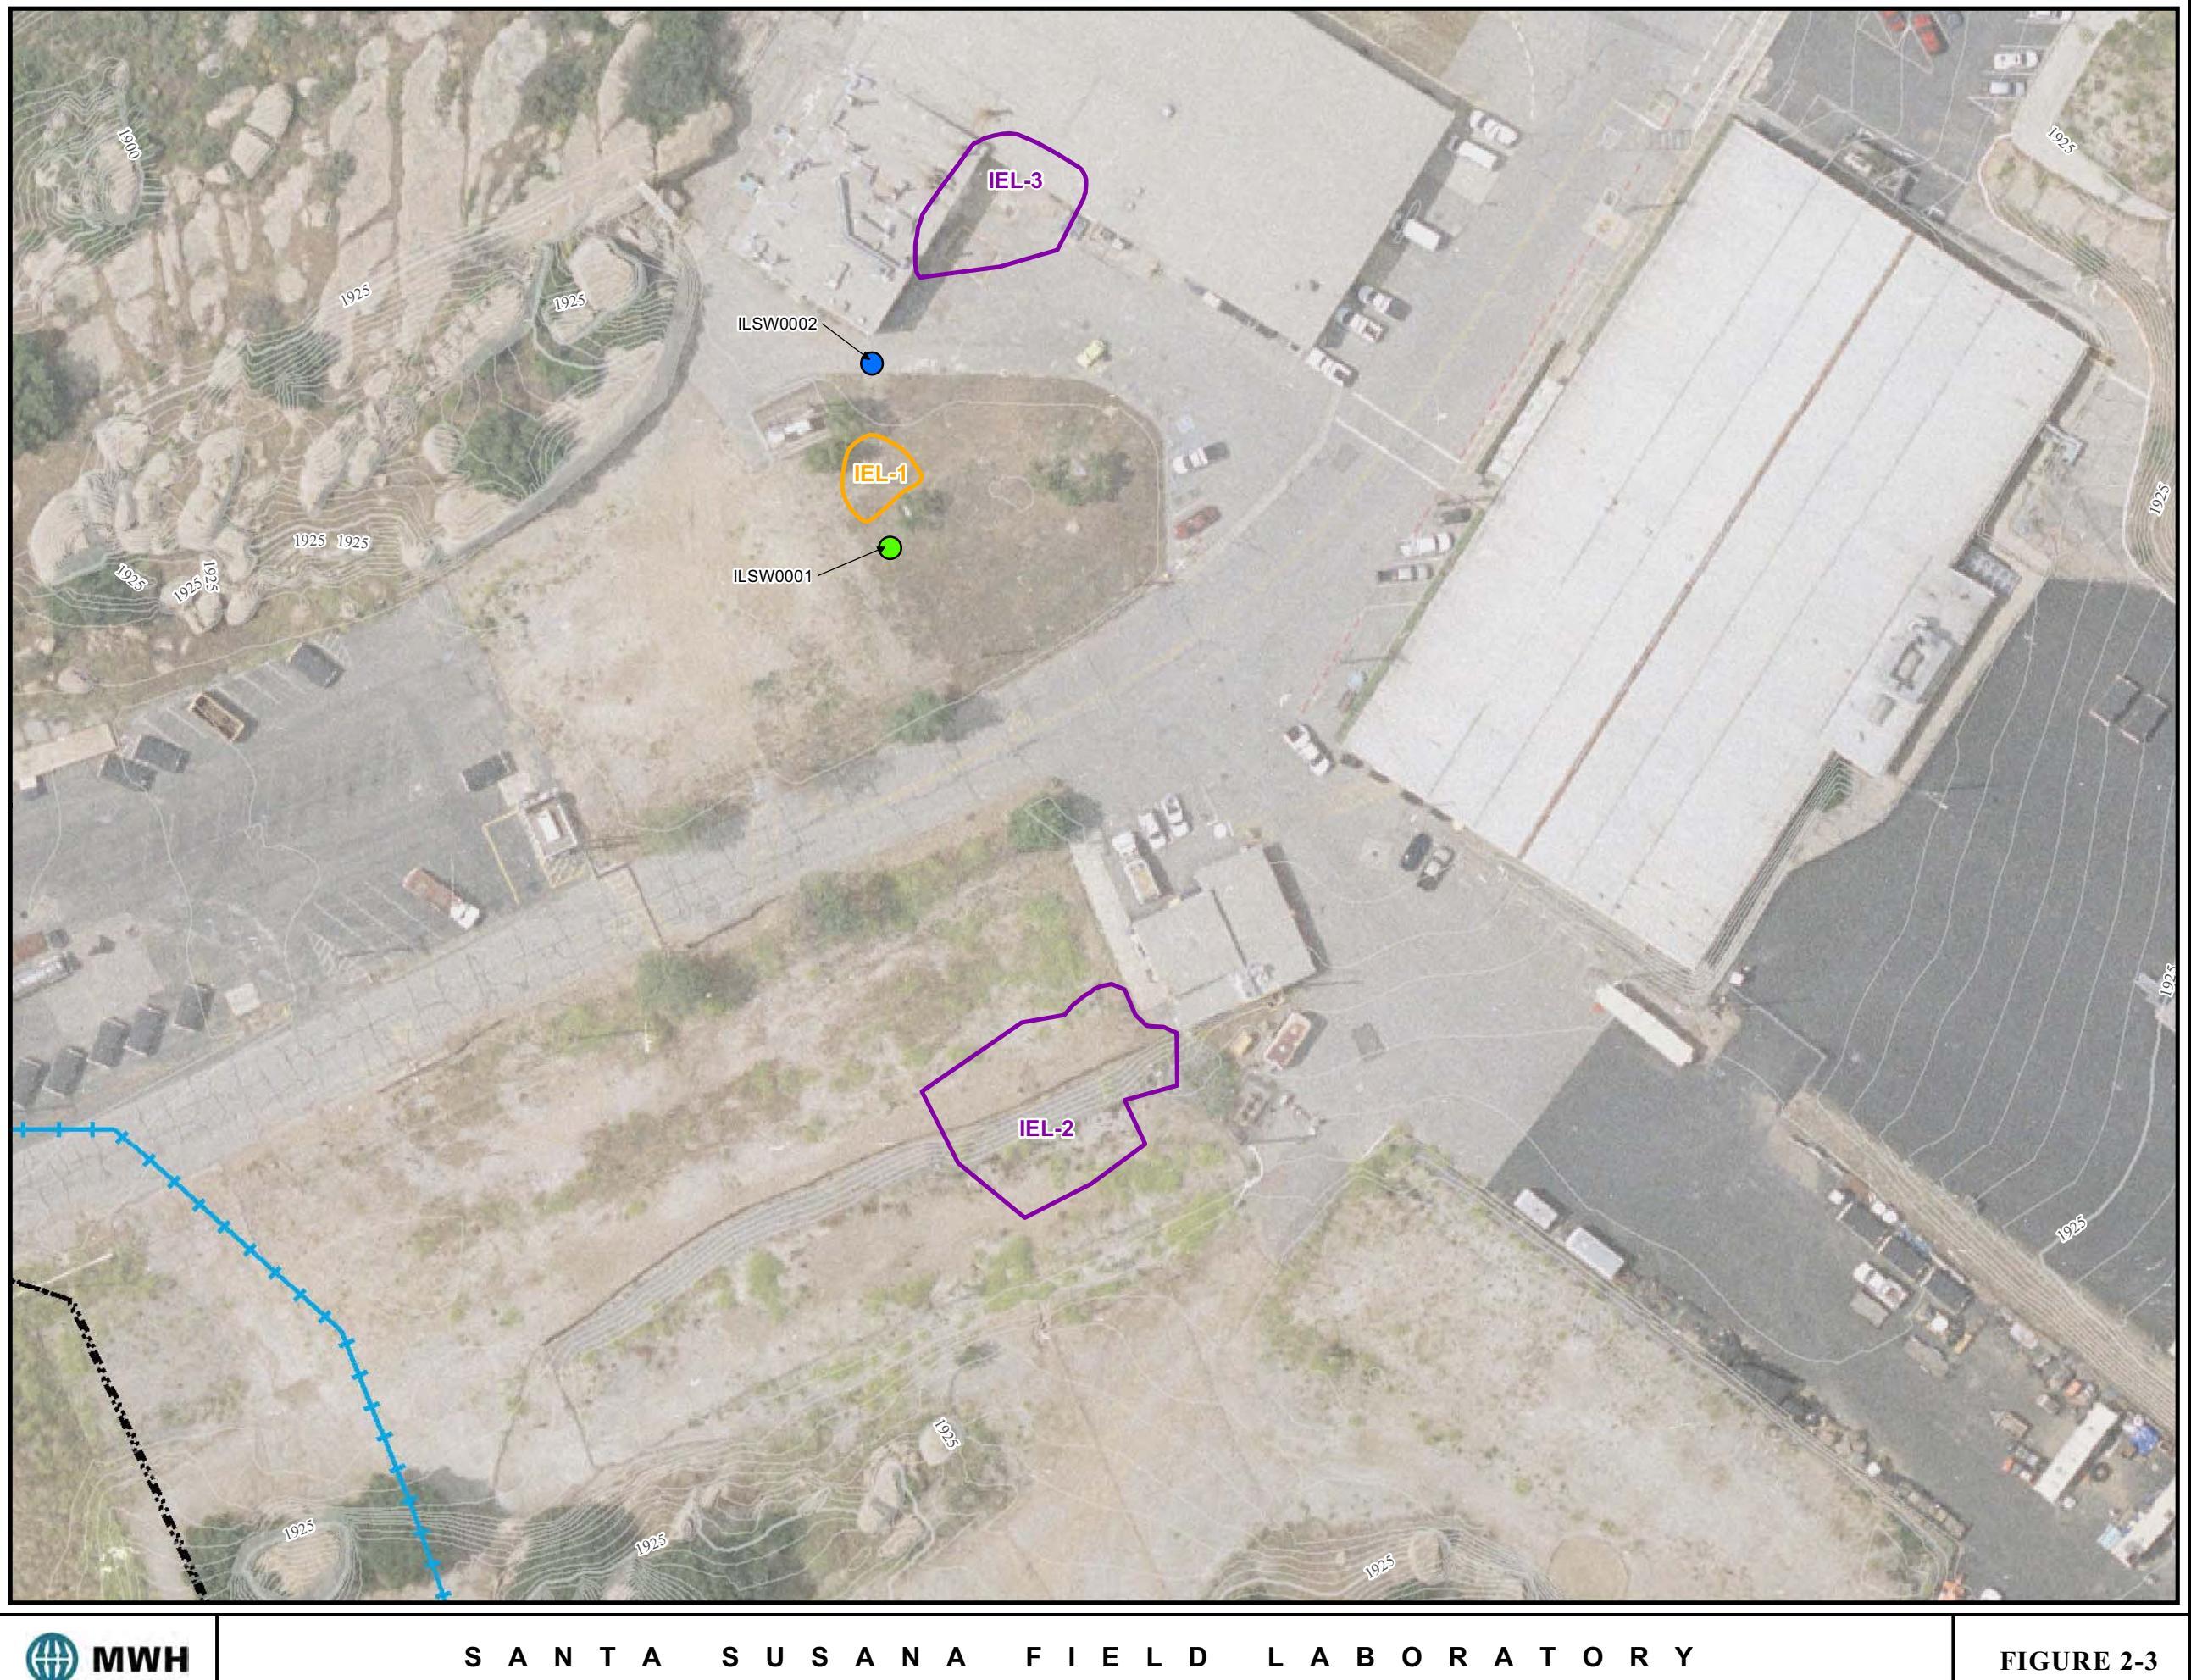
FIGURE 2-3

Outfall 009 BMP and ISRA Monitoring IEL Area

Performance monitoring and potential BMP subarea monitoring inspections were performed at the locations shown on this figure during daylight hours as soon as possible after the rain event began, and at 24 hour intervals during extended rain events. During inspections, if sufficient storm water runoff was observed at a sample location, a sample was collected from the flowing water. The dates on which samples were collected at a location are shown on the Figure; locations with no dates have never been sampled because flowing storm water has never been present during inspections.

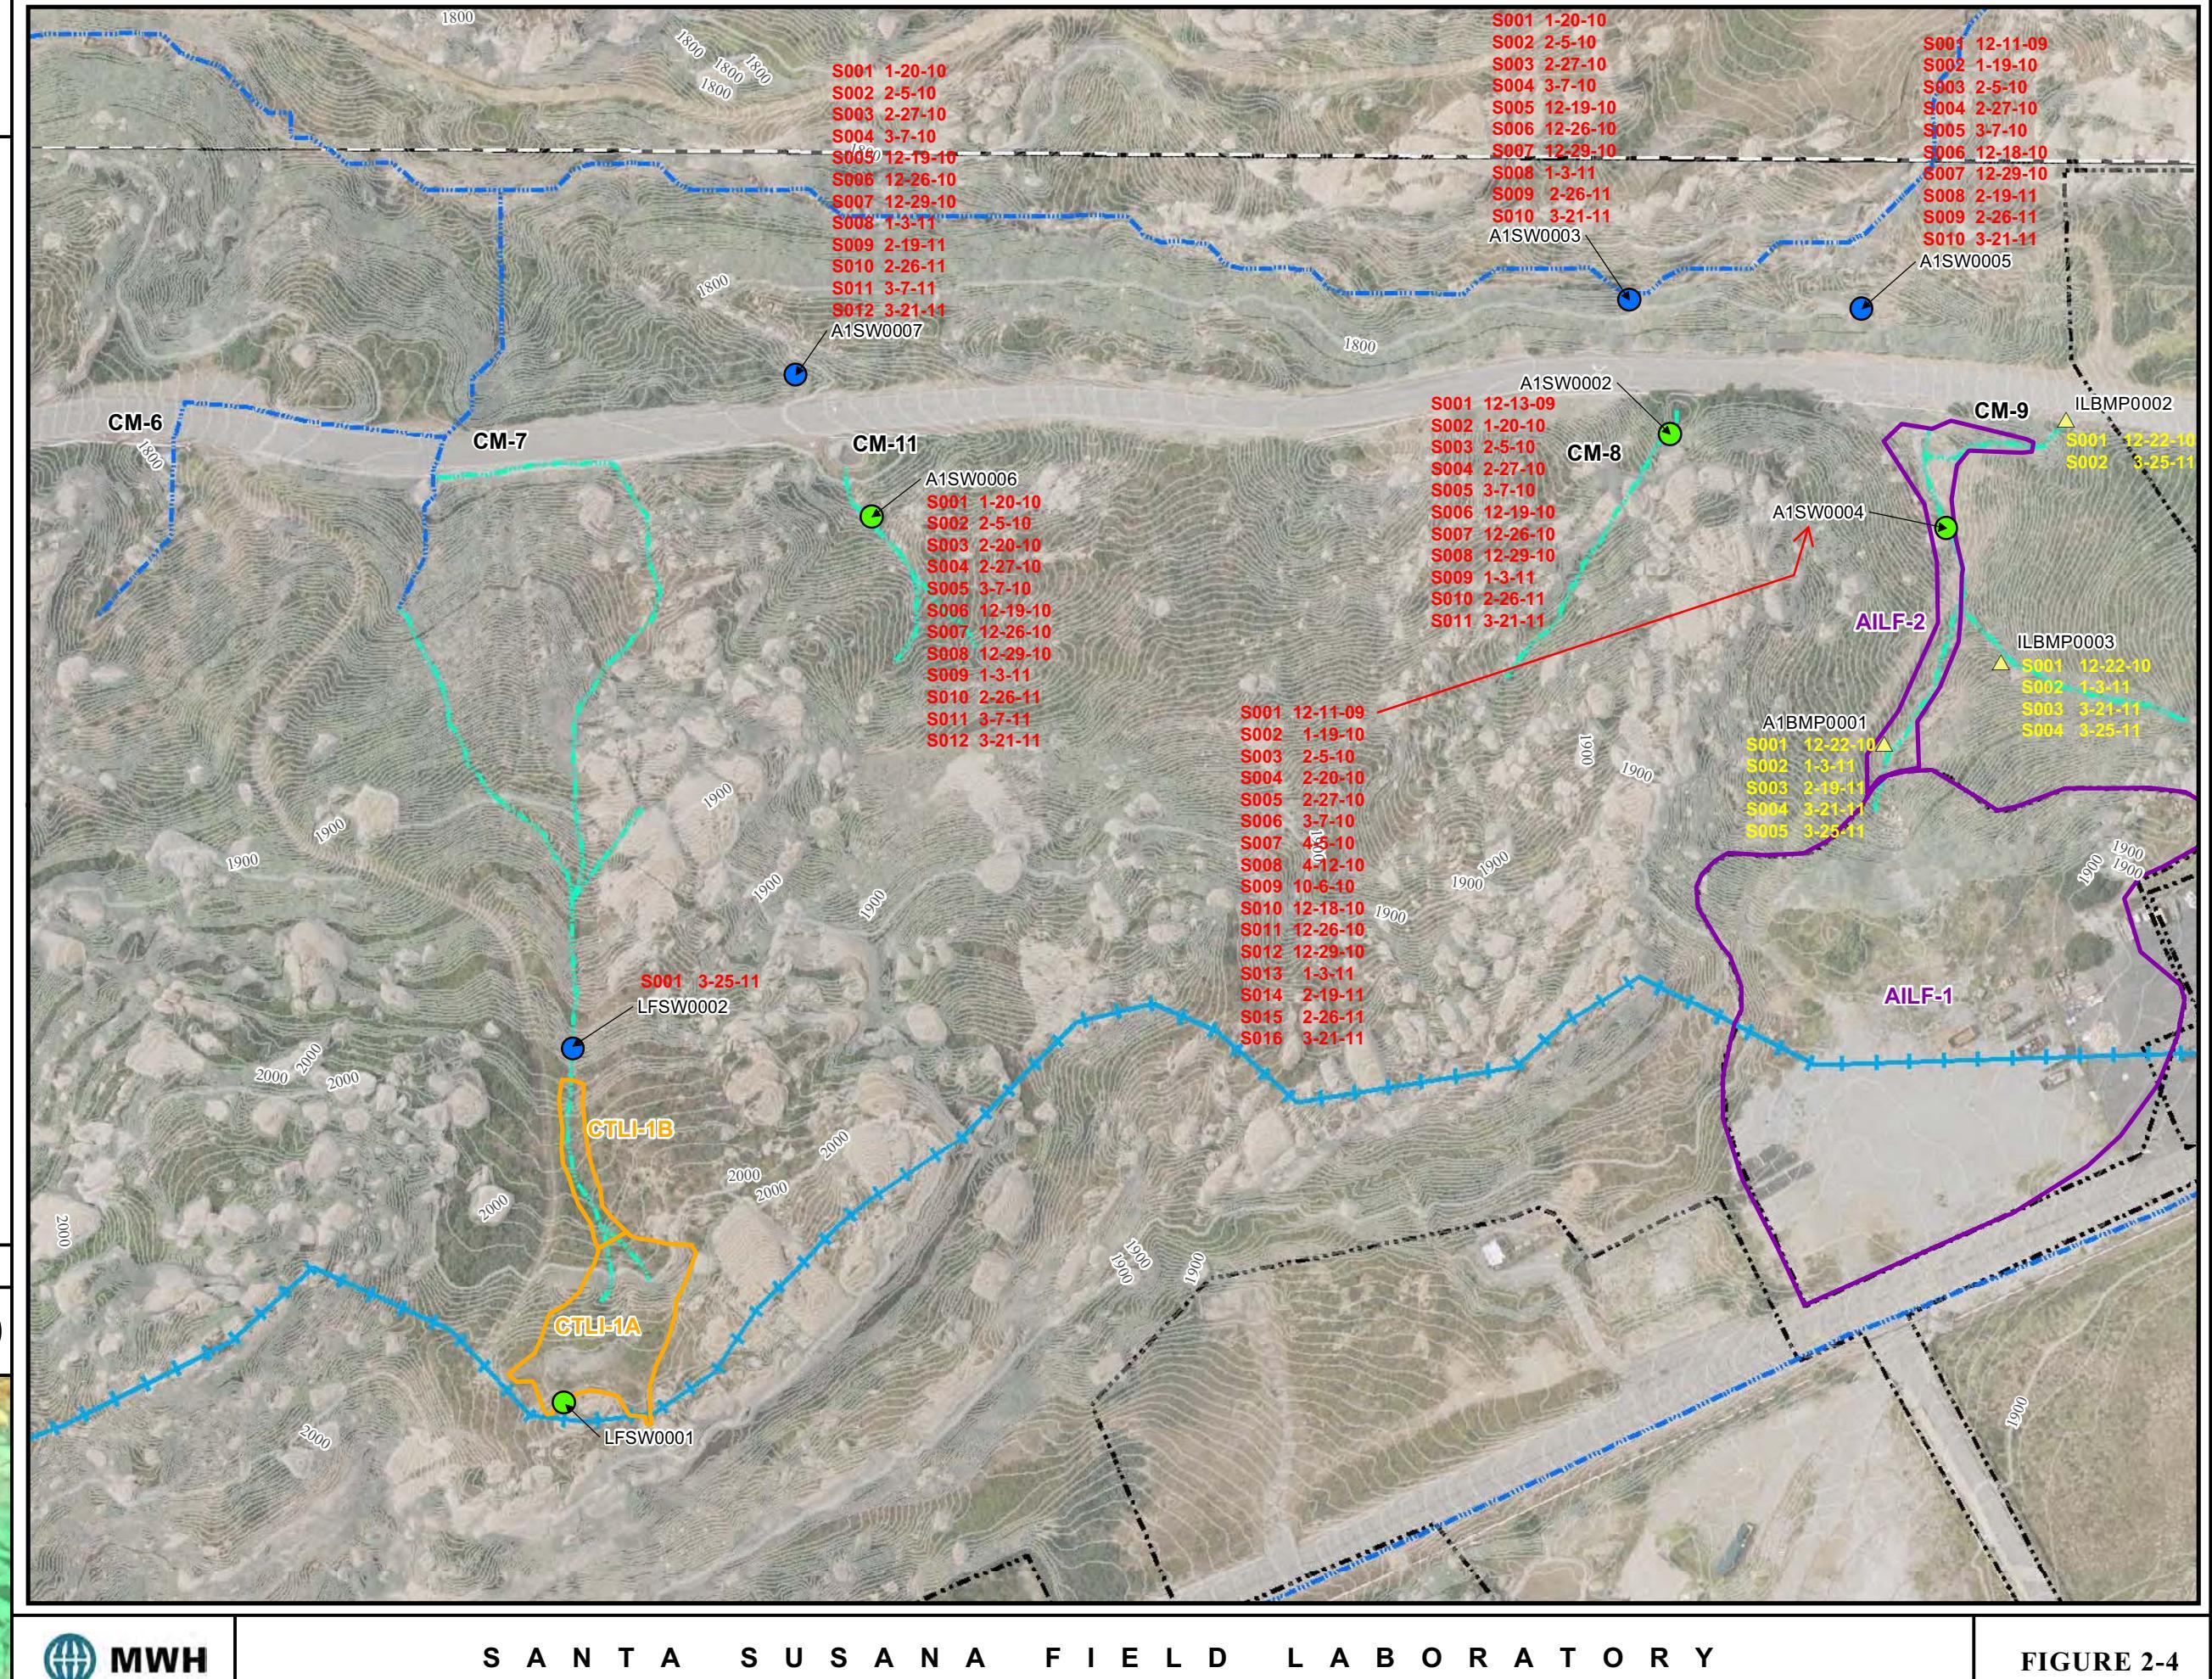
Outfall 009 BMP and ISRA Monitoring A1LF Area

Performance monitoring and potential BMP subarea monitoring inspections were performed at the locations shown on this figure during daylight hours as soon as possible after the rain event began, and at 24 hour intervals during extended rain events. During inspections, if sufficient storm water runoff was observed at a sample location, a sample was collected from the flowing water. The dates on which samples were collected at a location are shown on the Figure; locations with no dates have never been sampled because flowing storm water has never been present during inspections.

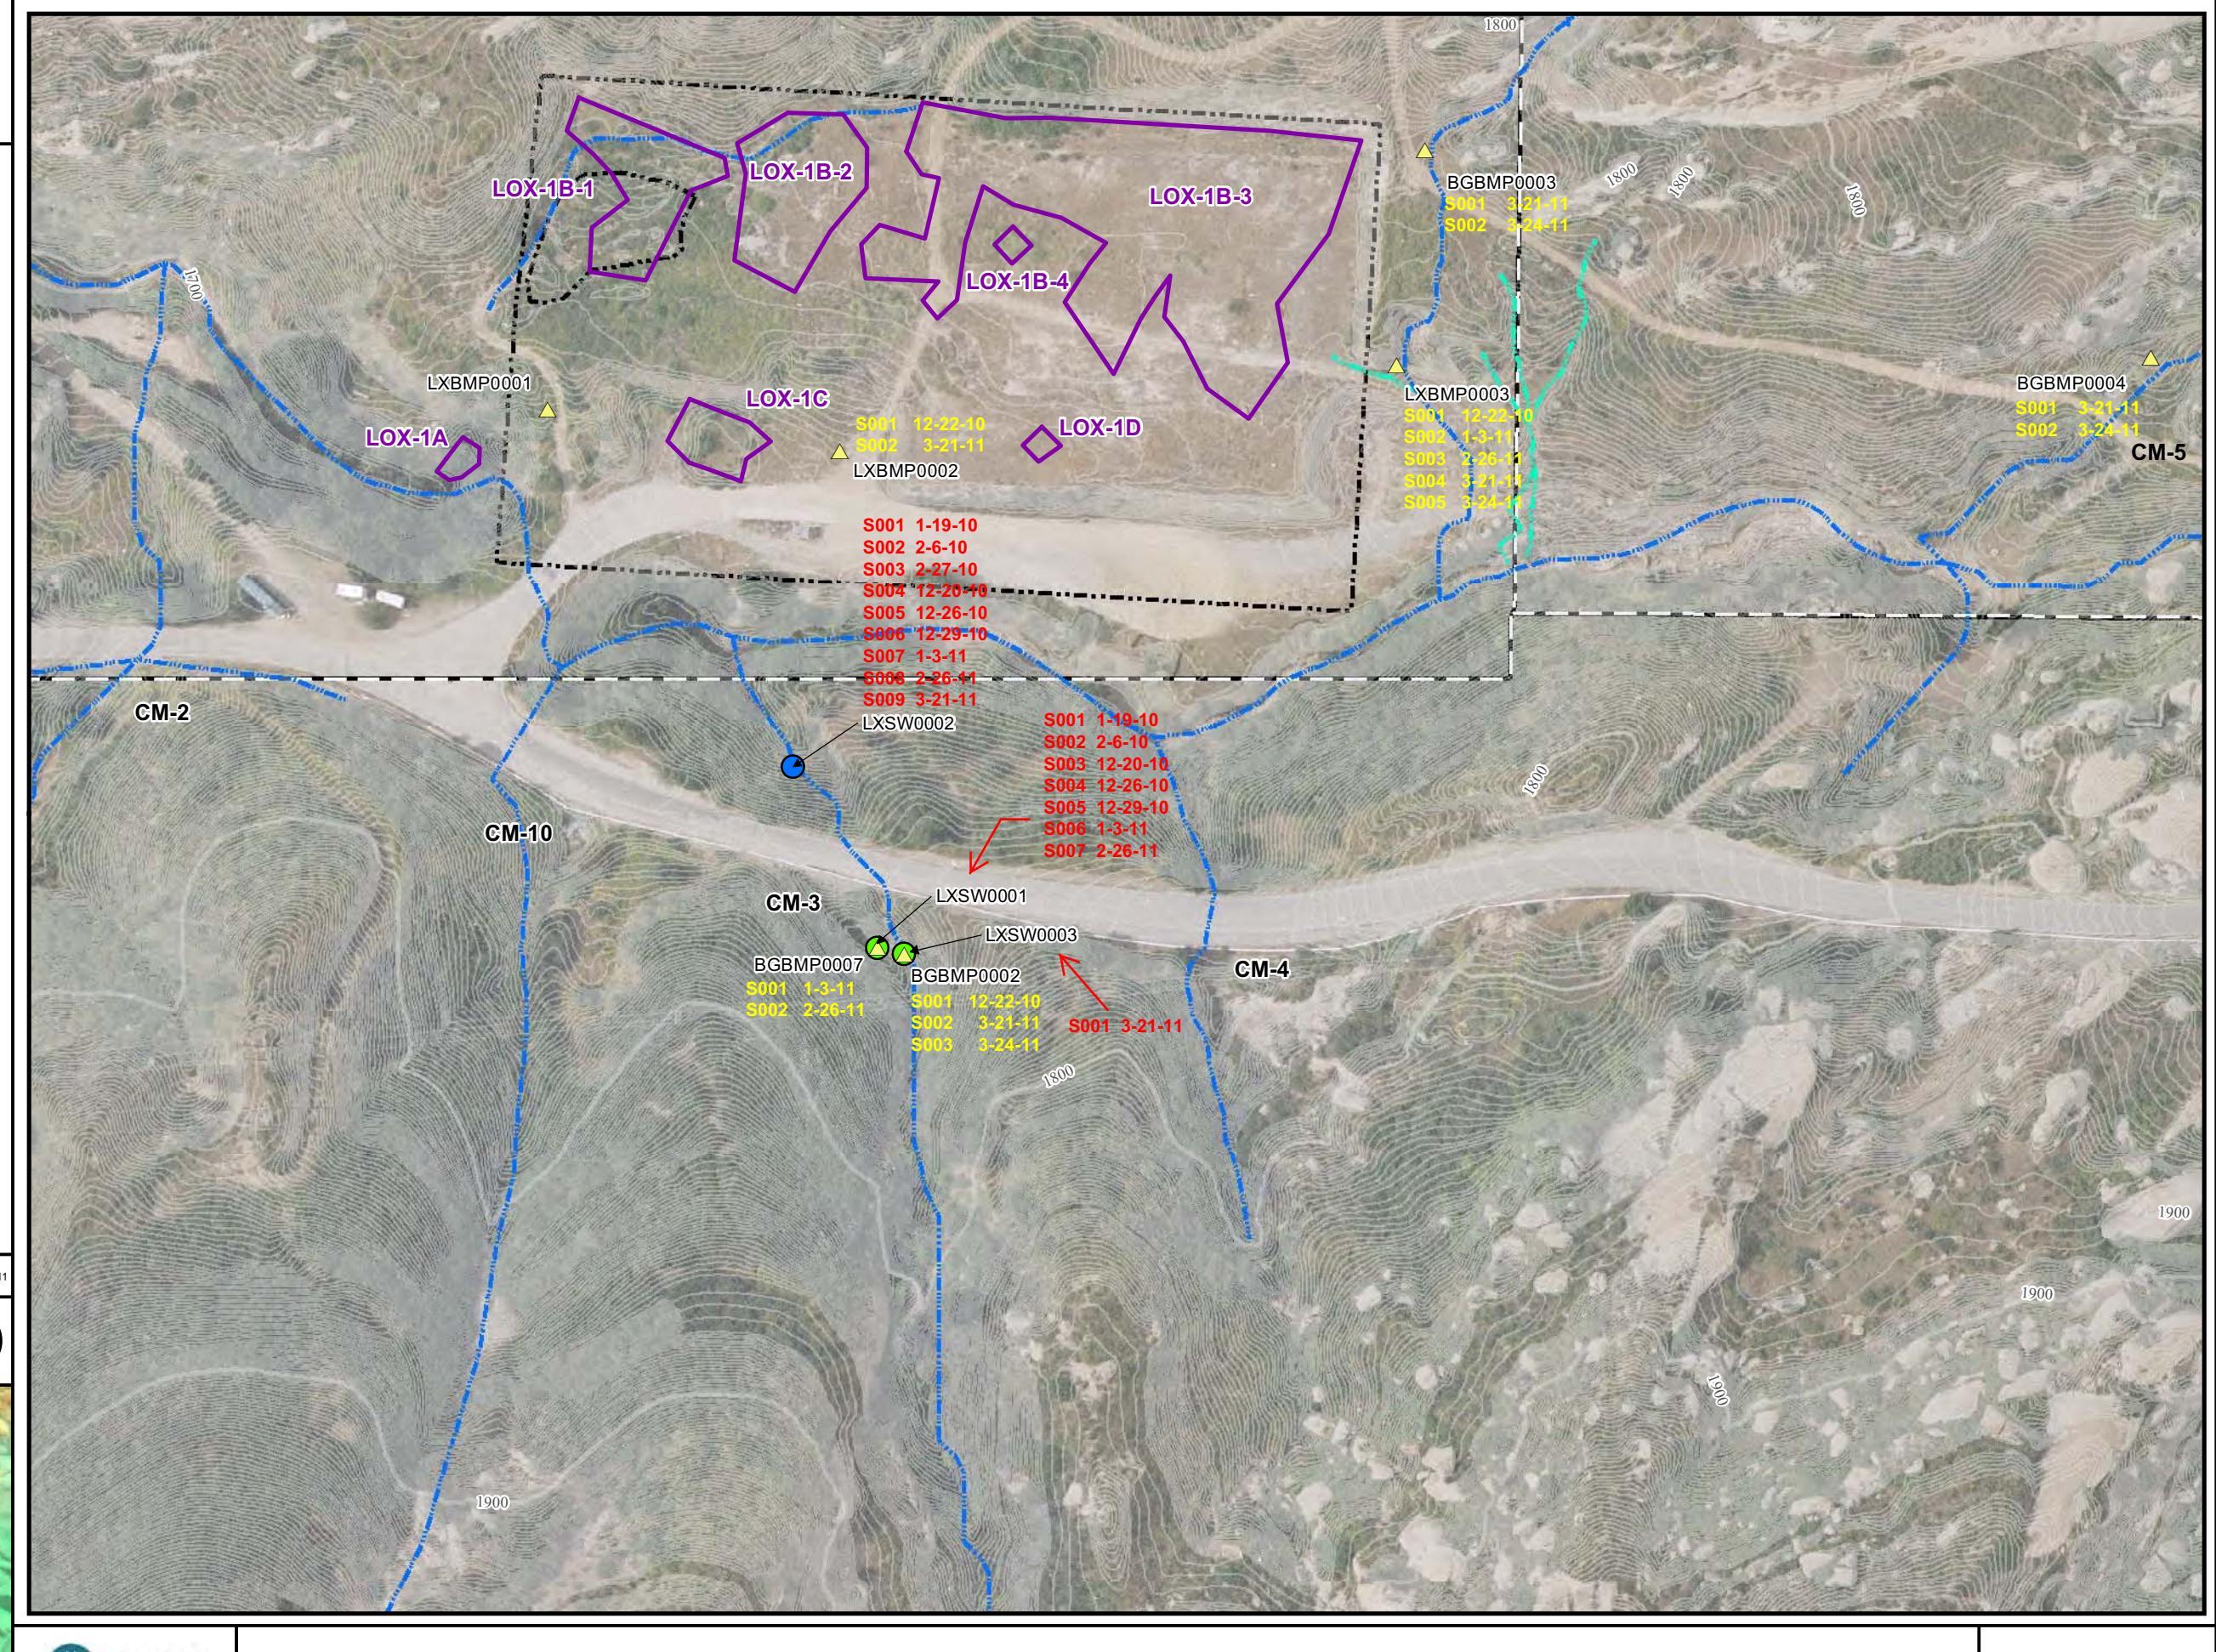
Outfall 009 BMP and ISRA Monitoring LOX Area

Performance monitoring and potential BMP subarea monitoring inspections were performed at the locations shown on this figure during daylight hours as soon as possible after the rain event began, and at 24 hour intervals during extended rain events. During inspections, if sufficient storm water runoff was observed at a sample location, a sample was collected from the flowing water. The dates on which samples were collected at a location are shown on the Figure; locations with no dates have never been sampled because flowing storm water has never been present during inspections.

- 3. Inspection/sampling at offsite monitoring locations subject to property owner approval. . Sample location LXSW0003/BGBMP0002 replaced sample
- location LXSW0001/BGBMP0007, per explanation on Tables 1-3 and 1-4
