Outfall 008 BMP and ISRA Monitoring

SANTA S U S A N A FIELD

LABORATORY

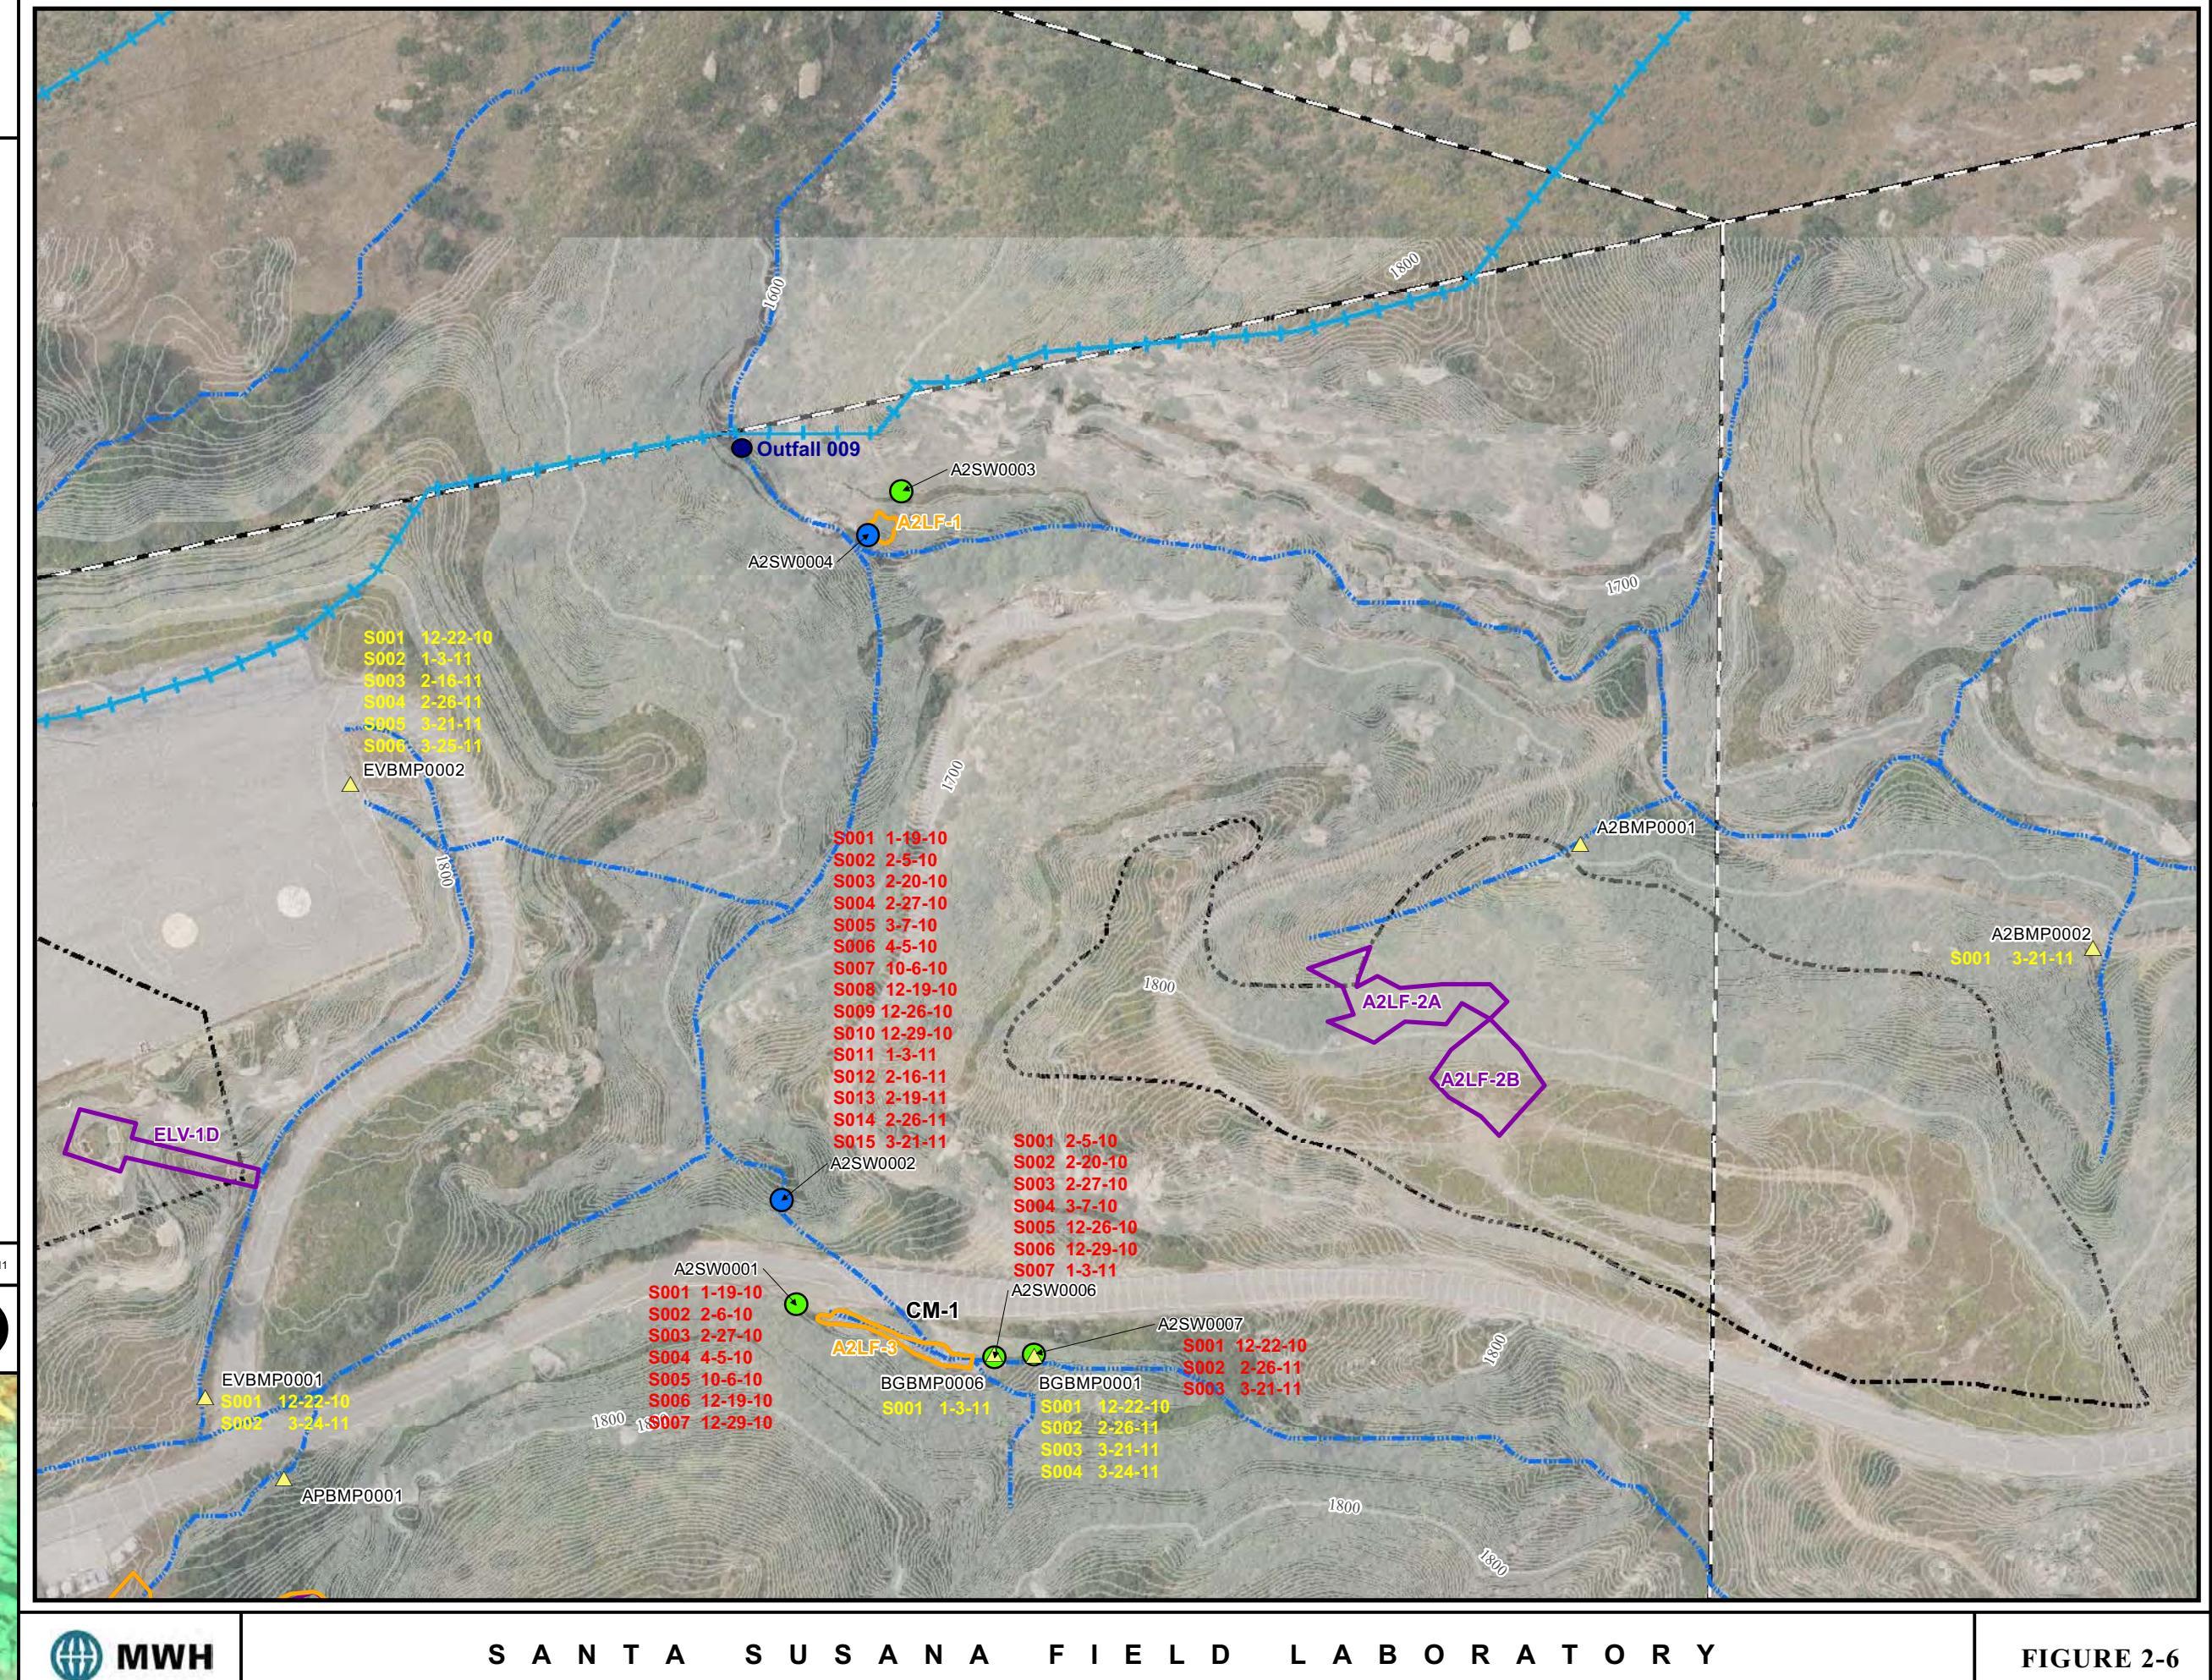
FIGURE 2-5

Outfall 009 BMP and ISRA Monitoring A2LF and ELV Areas

Performance monitoring and potential BMP subarea monitoring inspections were performed at the locations shown on this figure during daylight hours as soon as possible after the rain event began, and at 24 hour intervals during extended rain events. During inspections, if sufficient storm water runoff was observed at a sample location, a sample was collected from the flowing water. The dates on which samples were collected at a location are shown on the Figure; locations with no dates have never been sampled because flowing storm water has never been present during inspections.

- Topographic contours from 2010 Sage Consulting.
 Sample location A2SW0007/BGBMP0001 replaced sample location A2SW0006/BGBMP0006, per explanation on
- Tables 1-3 and 1-4

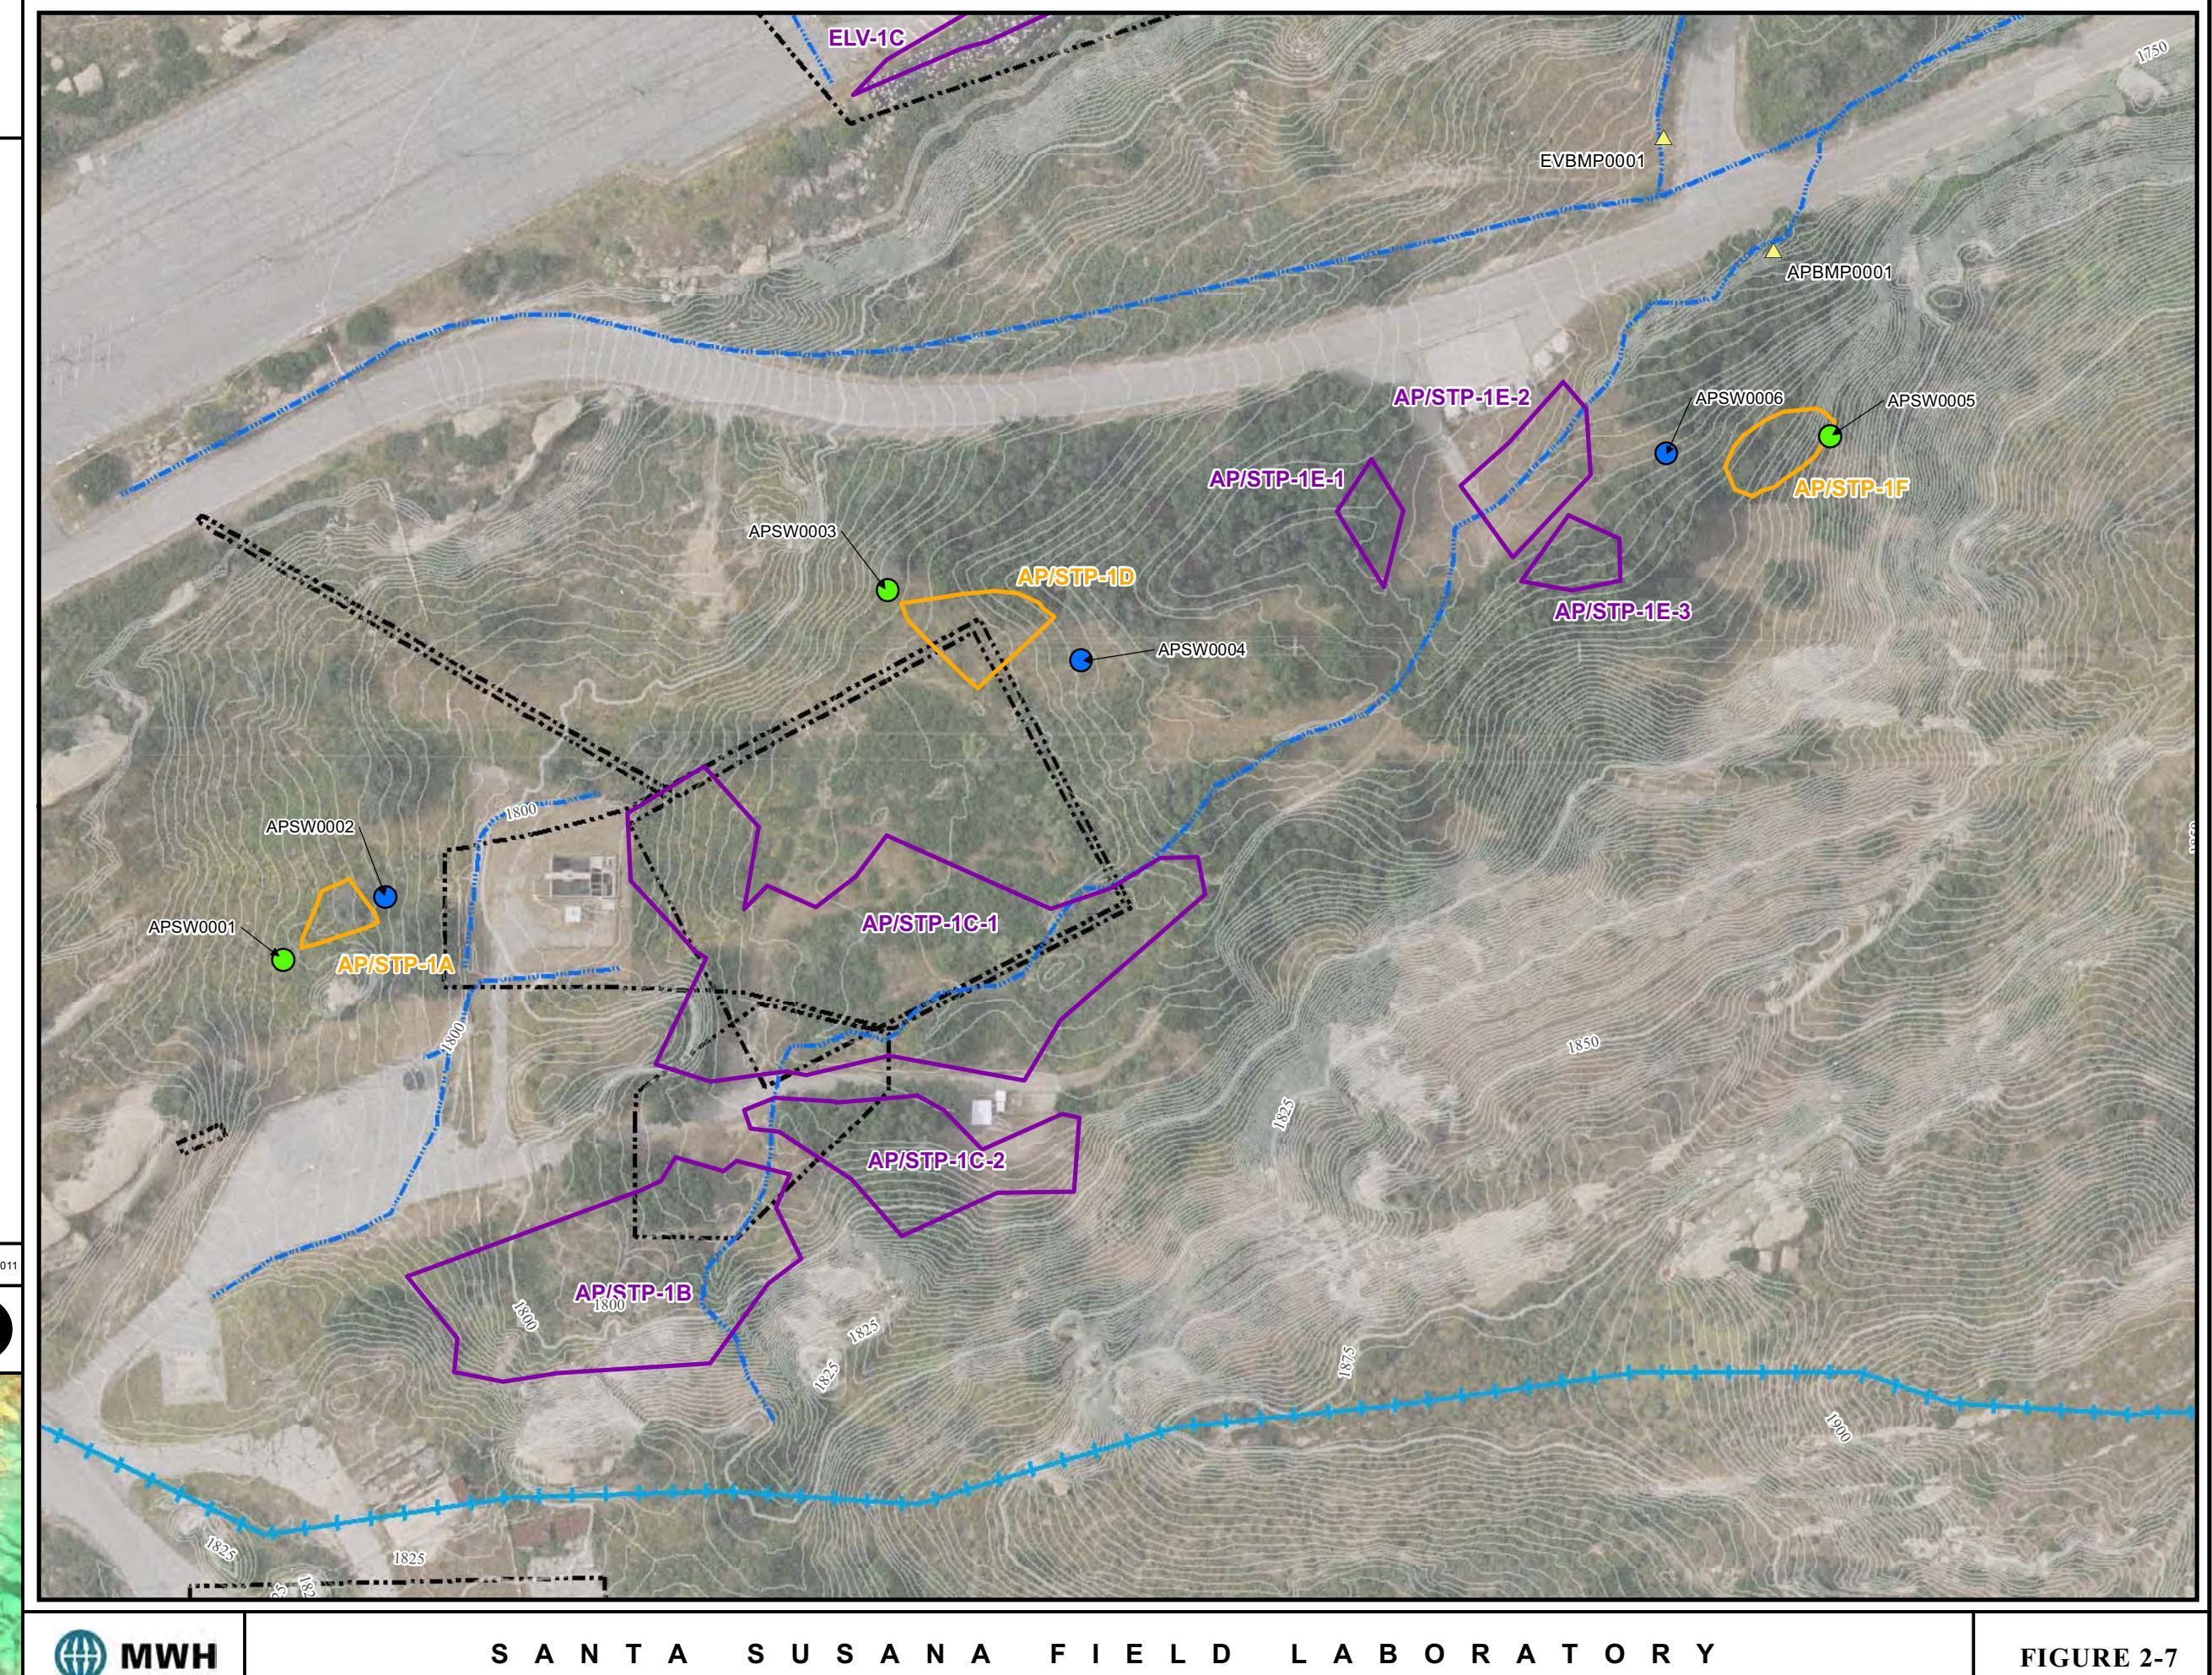
Outfall 009 BMP and ISRA Monitoring AP/STP Area

The dates on which samples were collected at a location are shown on the Figure; locations with no dates have never been sampled because flowing storm water has never been present during inspections.
